**BAGHDAD POLICE COLLEGE  
BAGHDAD, IRAQ**

**SIGIR PA-06-078.2**

**SIGIR PA-06-079.2**

SUBJECT: Report on Project Assessments of Reconstruction Work Performed Under Task Orders 06 and 29 at the Baghdad Police College, Baghdad, Iraq (Report Numbers SIGIR PA-06-078.2 and PA-06-079.2)

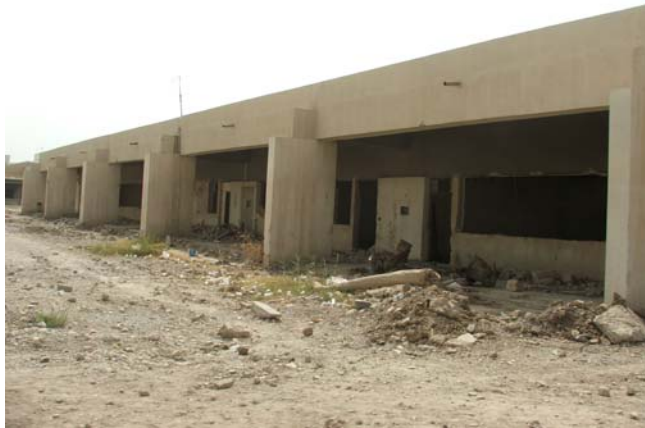
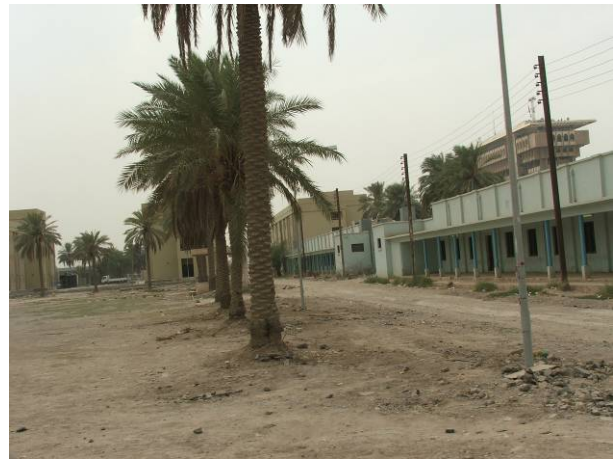
The description of the facility (pre-construction) was based on information obtained from the contract, the U.S. Army Corps of Engineers (USACE) project file, and BPC personnel. The project site is located at the existing Baghdad Police College campus, in Baghdad, Iraq. The surrounding area consists of residential homes and government buildings, such as the Ministries of Interior and Oil. The BPC previously was a three-year officer training facility. However, with an emphasis of providing a large number of cadets through Basic Police Training, this facility was determined to be insufficient. The existing facility consisted of a number of buildings, constructed approximately between 1935 to 1944. The existing buildings were in various stages of decay (Site Photos 1 and 2).

**Site Photos 1 and 2. Existing buildings at the Baghdad Police College**

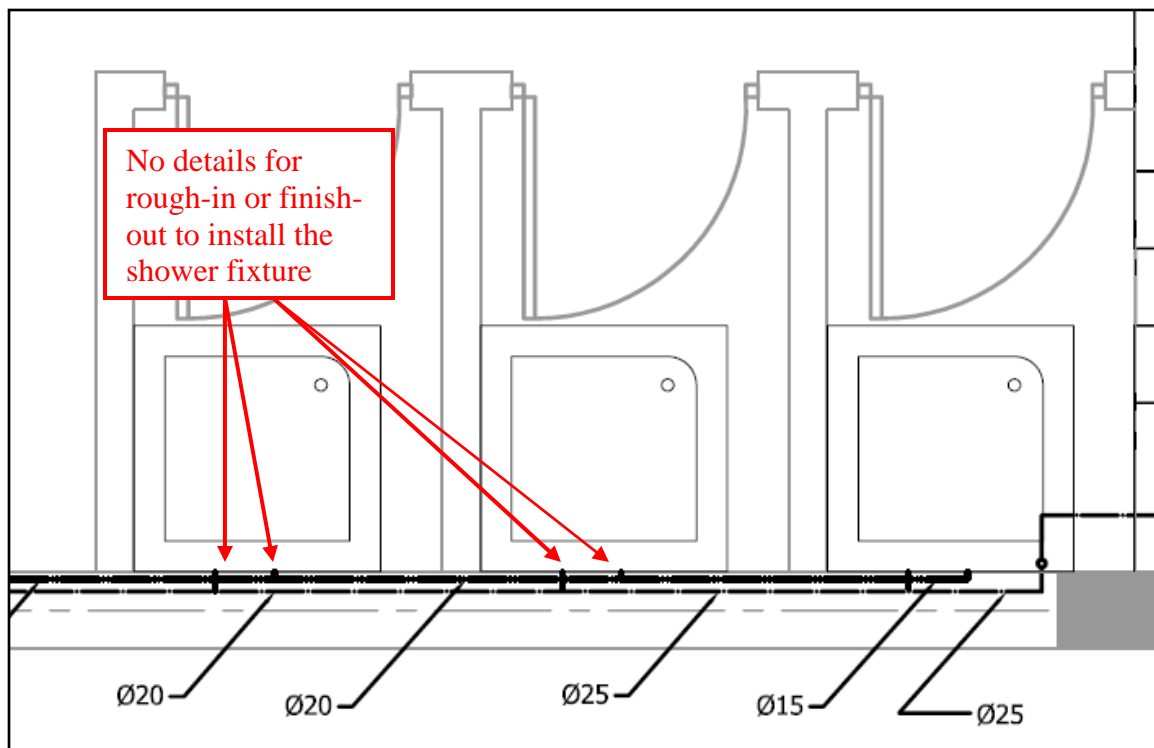
Detailed design drawings for the rough-in and finish-out of the plumbing fixtures were not provided by the contractor. Instead the drawings were generic and did not specify the distance that the hot and cold water lines should extend beyond the wall (i.e. rough-in) for the plumber to connect to the shower faucet and head (Figure 1). In addition, the drawings do not provide an enlargement of one shower as an example to provide specific installation details, such as the type of plumbing fixtures to use (i.e. finish-out). Without detailed design drawings, the subcontractor does not have adequate guidance to properly install the water lines and plumbing fixtures.

Figure 1. Contractor design for installation of hot and cold water lines for cadet barracks showers

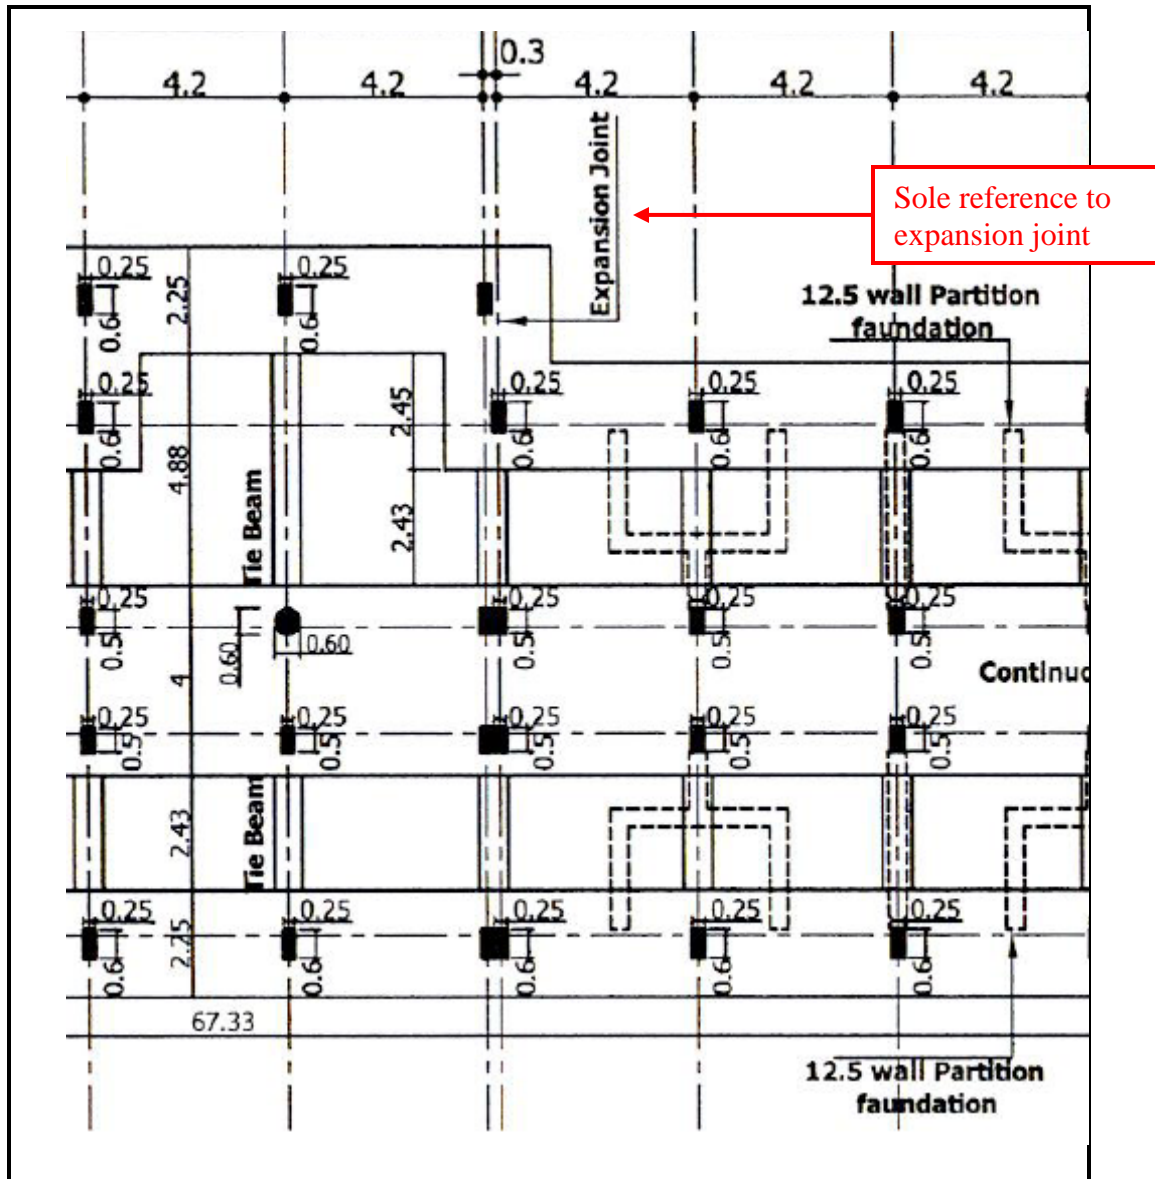
The 60% design drawings for the instructors' barracks did not include any specific details for the use and installation of expansion joints; instead there are only vague references to the expansion joints in the design drawings (Figure 3). The government engineer's design reviews did not identify the obvious absence of this item on the design drawings and subsequently did not require the contractor to resubmit the drawings with exact expansion joint details. Specific expansion joint details are critical, since properly designed and correctly installed joint systems are capable of protecting buildings and structures from damage caused by thermal expansion and contraction as well as anticipated foundation movements.

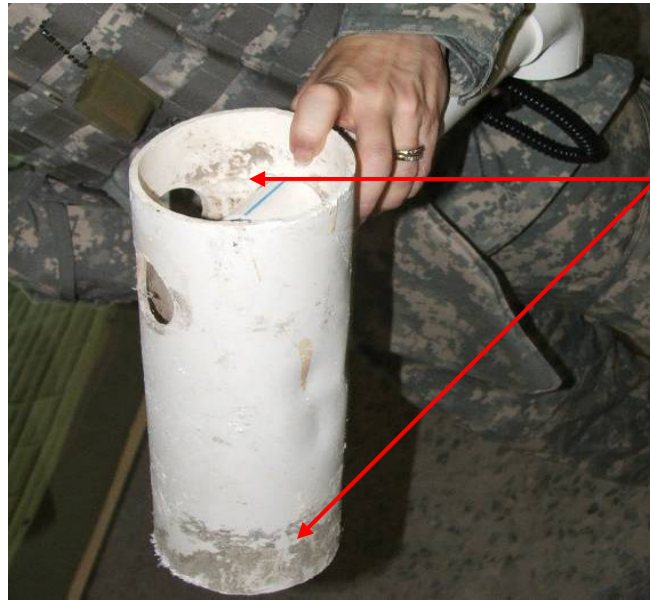
According to the USACE Gulf Region Division (GRD) and BPC representatives, the common practice of local subcontractors is to cement joints in the bathroom areas (Site Photos 8 and 9); however, this practice is strictly prohibited by the IPC. In an earlier section of this report, we mentioned the lack of the required number of cleanouts in the design drawings. Site Photo 10 shows no cleanouts for several traps and 90 degree turns. Not only is a cleanout required by the IPC, without it solid waste will collect and ultimately clog the pipe.

Evidence of failed cemented joints

**Site Photo 8. Piece of original plumbing pipe removed from cadet barracks**

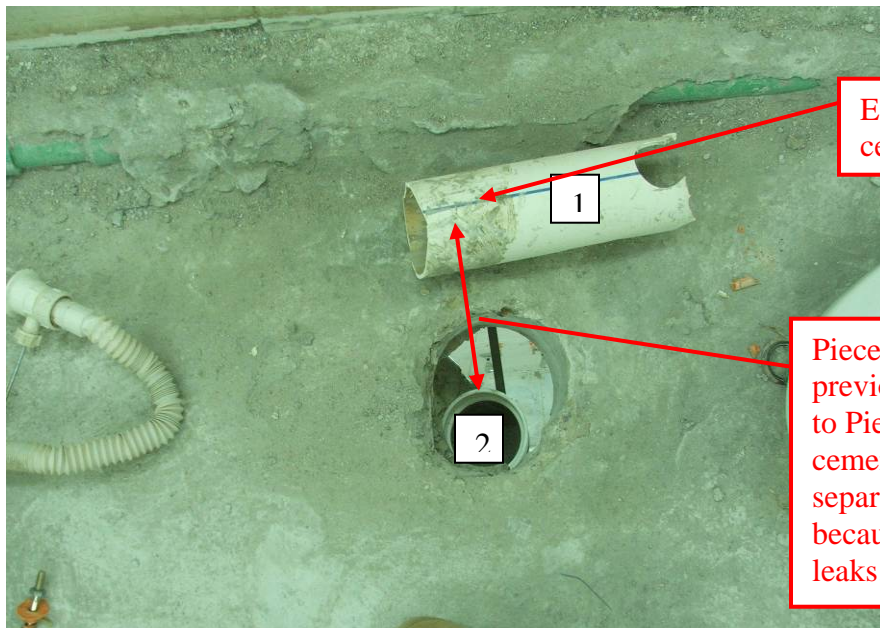
Evidence of cemented joints

Piece 1 was previously connected to Piece 2 with cement. Piece 1 was separated from Piece 2 because of water leaks.

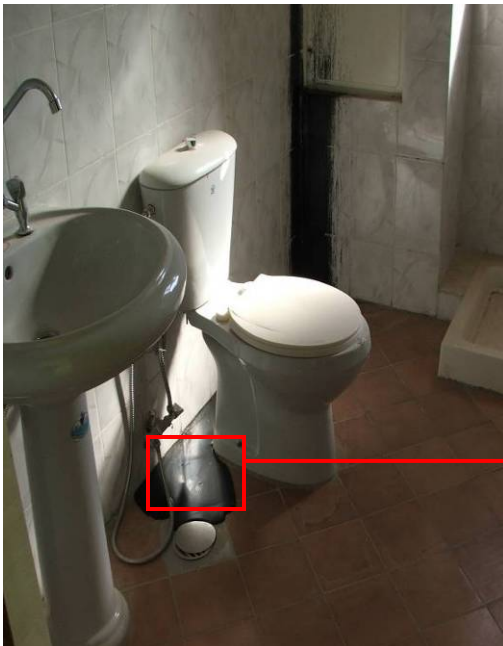
In the instructors' barracks we identified a poorly installed main water line connection, tar damage in the bathrooms, which leaked from the roof down to the ground floor, and a poorly installed electrical outlet (Site Photos 13-16). The main water line connection is peculiar since multiple sized pipes are used. Specifically, there is a reduction from the 4" main pipe to a 2" pipe and then expanding to a 4" pipe.

**Site Photo 14. Tar leaking from roof to ground bathroom.**

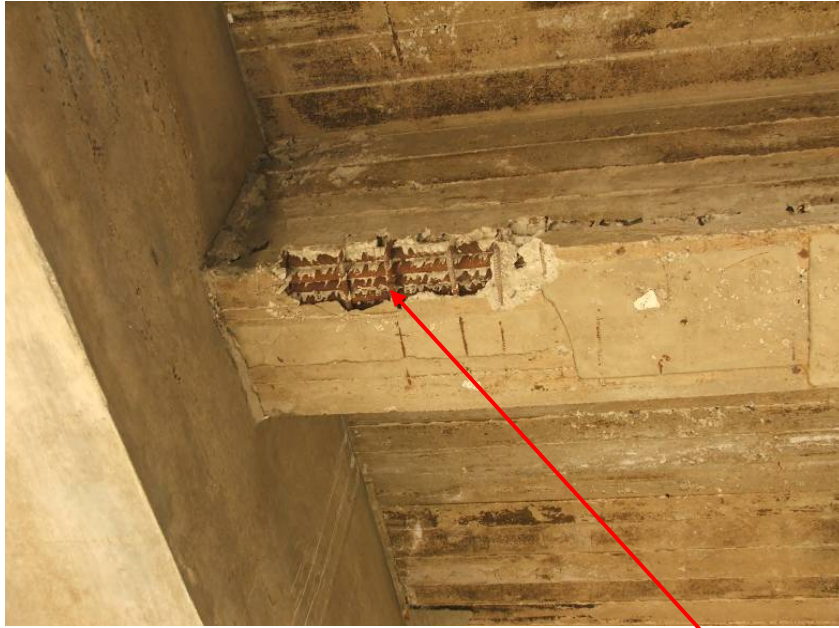
- Areas of severe reinforcement bar exposure on the surface of the load-bearing reinforced concrete ceiling beams (Site Photos 21-23)
- Areas of severe concrete segregation and honeycombing (Site Photos 24-26)
- Poor quality brick workmanship (Site Photo 27)

**Site Photo 22. Reinforcement bar exposure**

Areas of severe  
reinforcement bar  
exposure

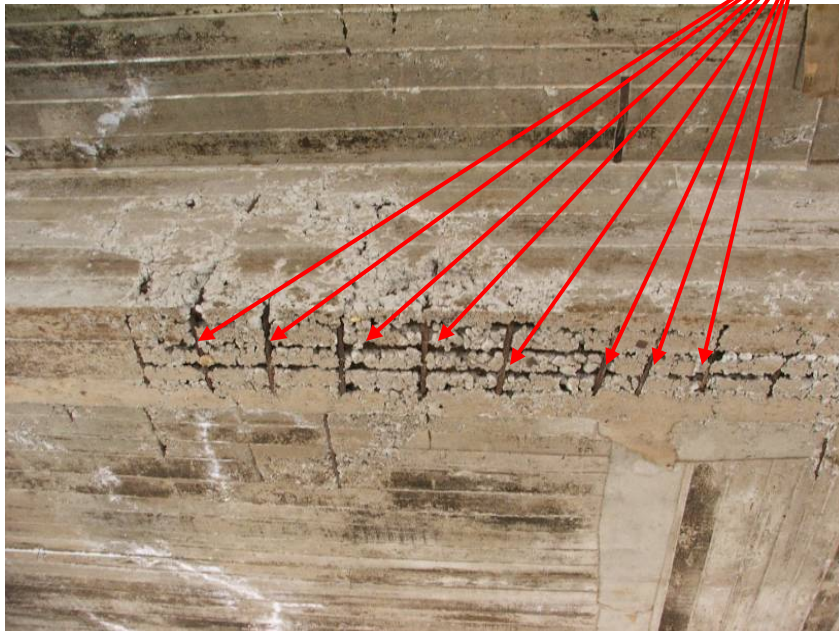
**Site Photo 23. Example of reinforcement bar exposure**

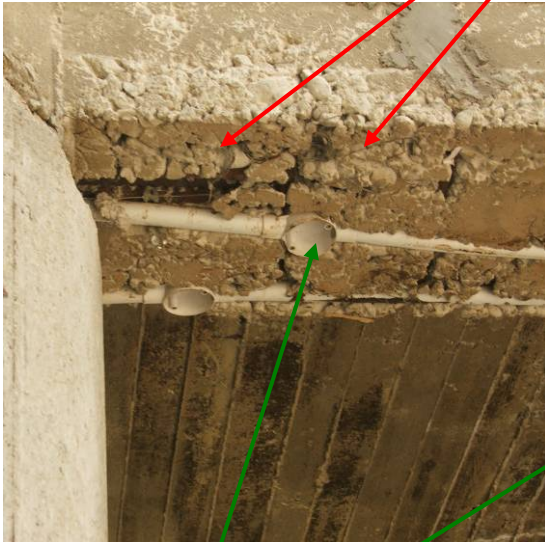
Areas of honeycombing,  
voids, and segregation

**Site Photo 24. Concrete segregation and electrical conduit exposure**

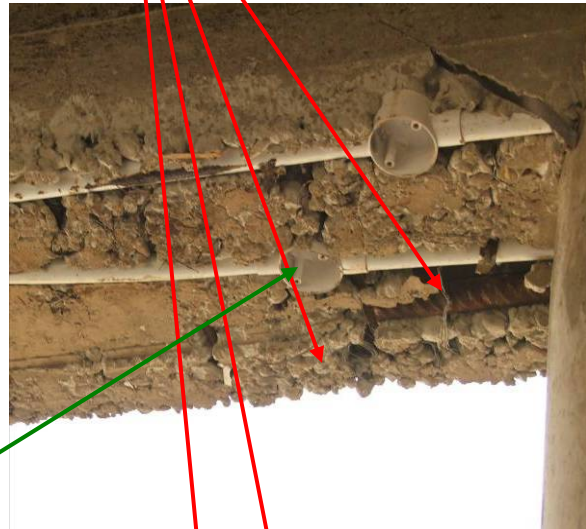
**Site Photo 25. Concrete segregation and electrical conduit exposure**

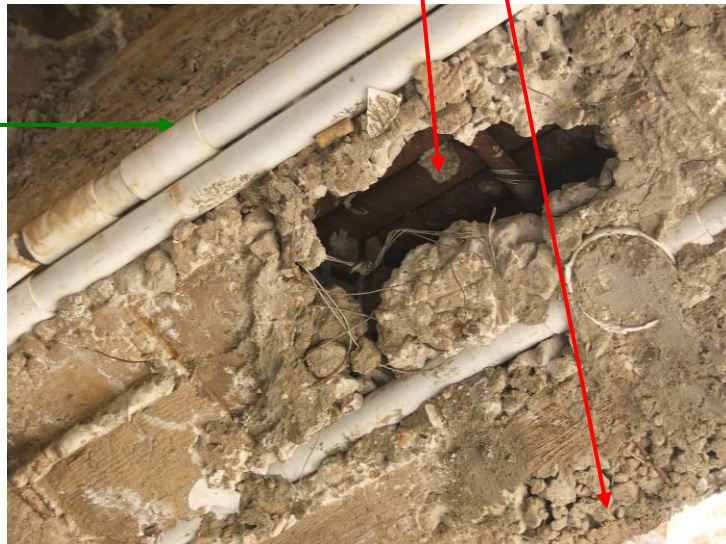
Electrical conduit  
exposure due to  
incorrect placement

**Site Photo 26. Concrete voids and electrical conduit exposure**

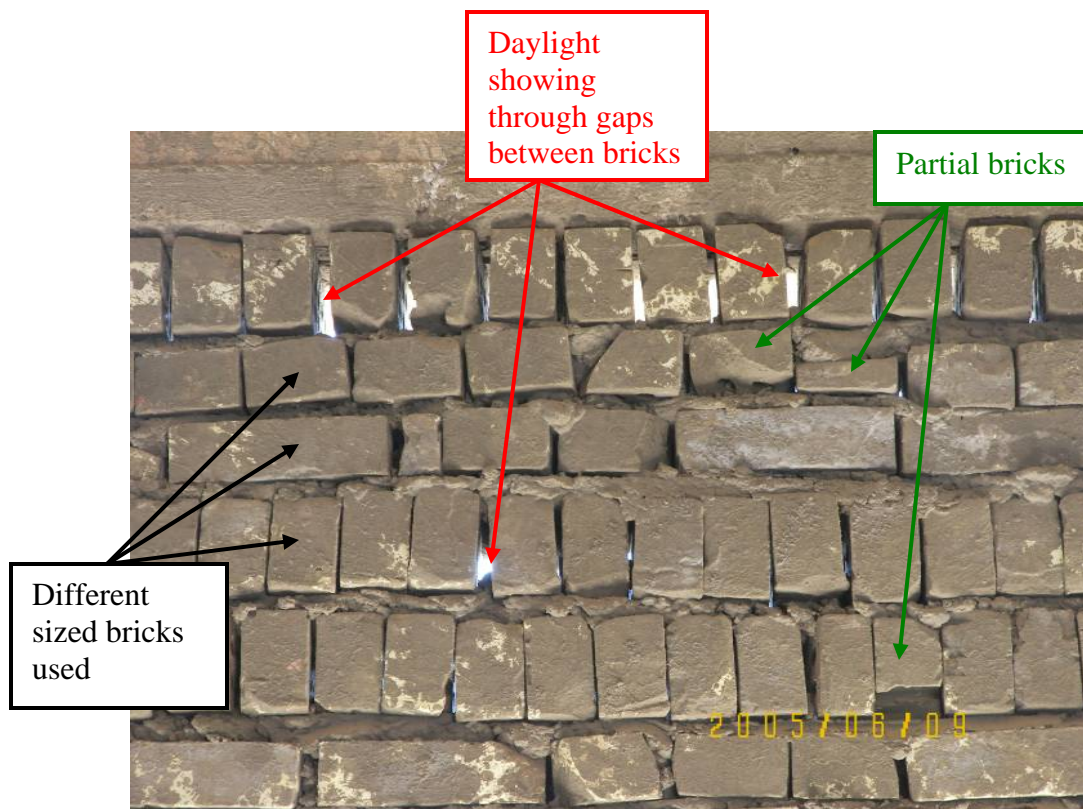
**Site Photo 27. Poor brick work – not level, gaps between bricks, different sized bricks, and partial pieces of brick used in the central laundry facility**

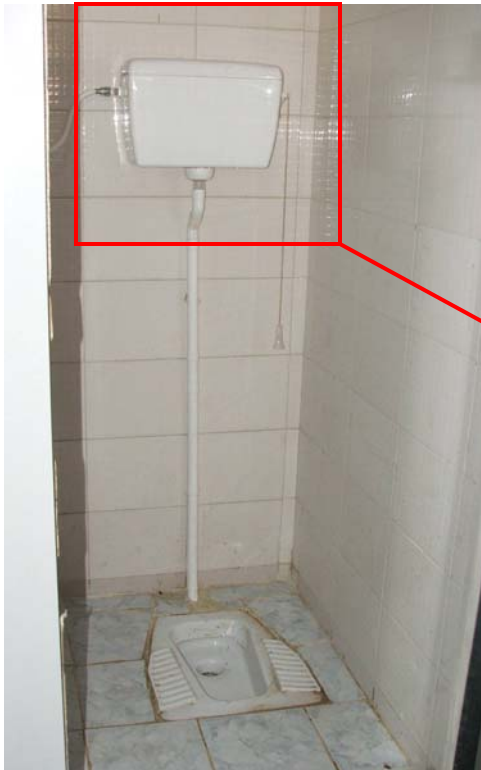
The plumbing fixtures used in the cadet and instructors' barracks bathrooms appeared to be low quality fixtures (shower heads, water supply lines, faucets, drain covers, etc) installed in the showers, wash stations (sinks), urinals, and water closets. Site Photos 28 and 29 show the type of plumbing materials used in the water closets, which included flexible water hoses, plastic supply tanks, and thin wall plastic tubing supplying water from the tank to the toilet. Site Photos 30, 31, and 32 show the shower fixtures, including the shower head, the thin metallic tubing used to supply water to the shower head, and the single clamp used to secure the water pipe to the wall. Over time, the clamp will dislodge from the wall and the shower water pipe will hang unsupported.

**Site Photo 28. Water closet in cadet barracks**

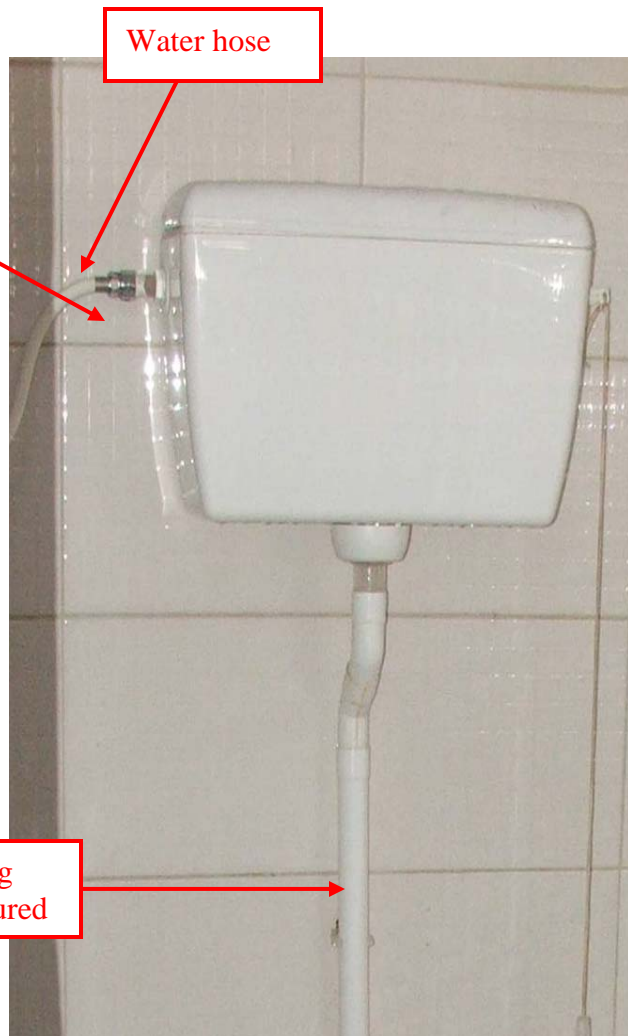
**Site Photo 29. Enlarged view of Site Photo 28**

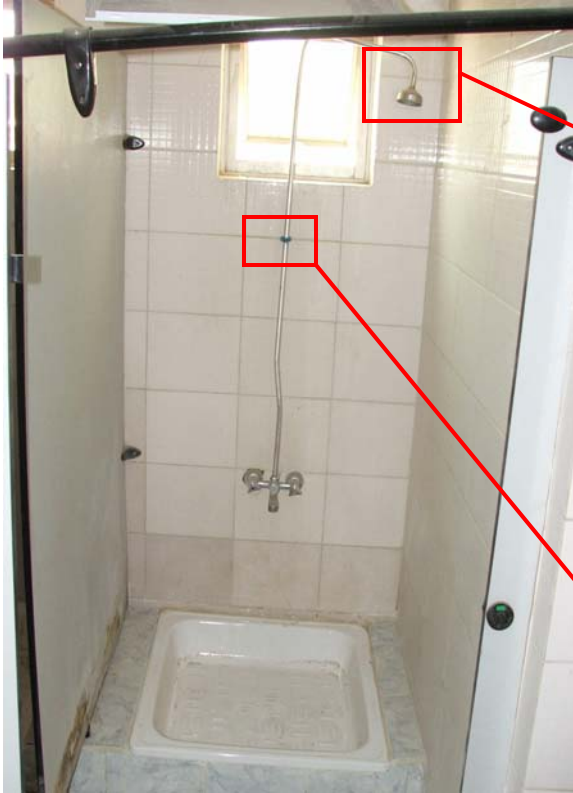
**Site Photo 30. Shower fixture in cadet barracks**

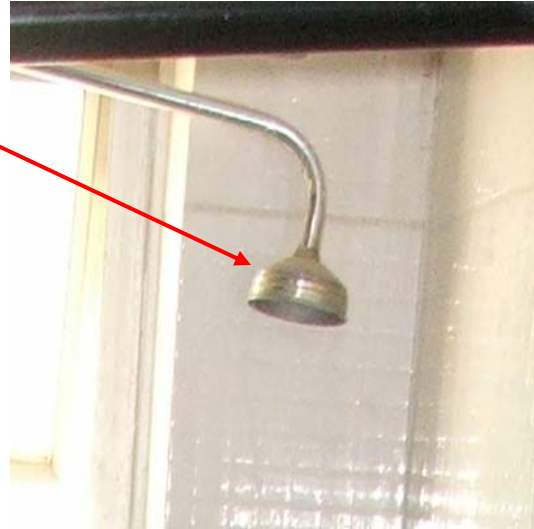
**Site Photo 31. Close-up view of shower head**

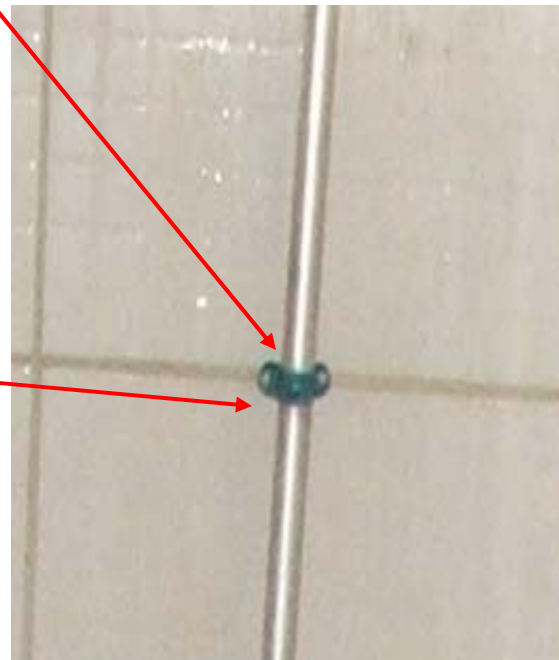
**Site Photo 32. Close-up view of clamp**

Two screws of the clamp holding the shower pipe are driven into cement mortar joint between the tiles will not provide needed strength to keep the pipe in place

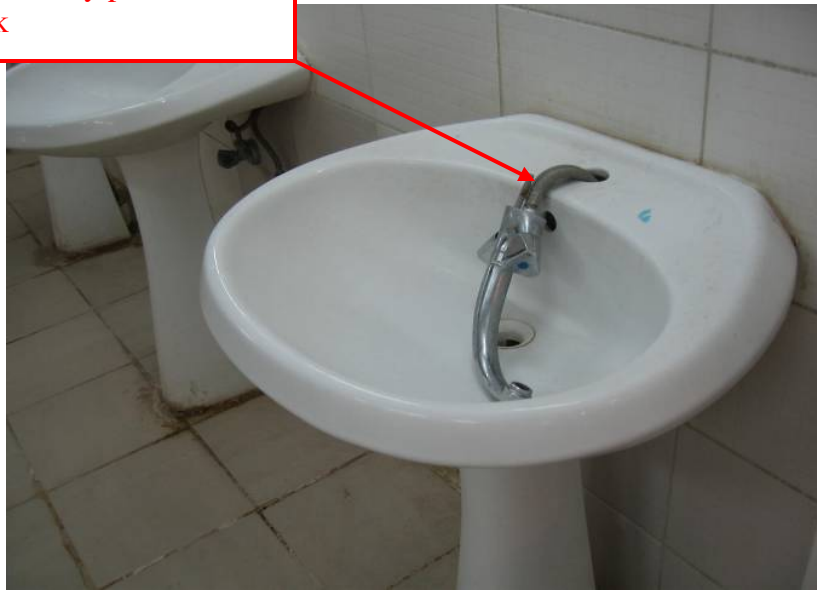
During our site visits to the BPC, we witnessed the problems associated with the use of the low quality parts. For instance, the clamps holding the shower water pipe to the wall were dislodged; the thin metallic tubing was bent; multiple sink faucets were pulled from the sink and were leaking (Site Photos 33 and 34); and shower faucets were leaking (Site Photo 35).

Low quality plumbing  
fixture – easily pulled from  
the sink

**Site Photo 33. Bathroom sink in cadet barracks**

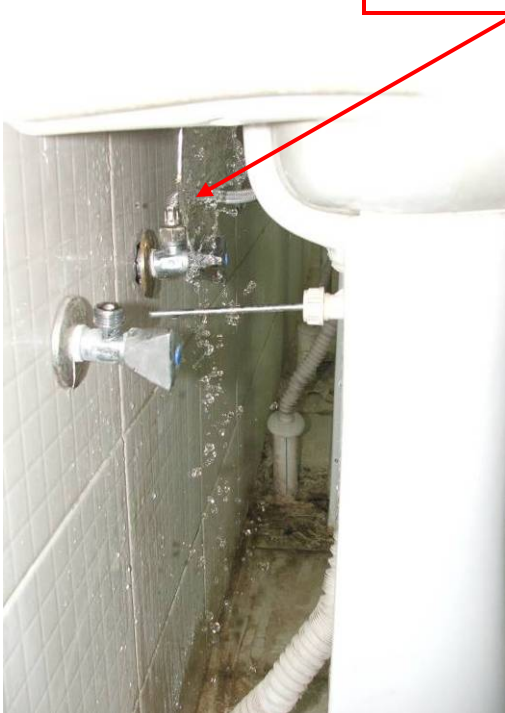
Low quality plumbing  
fixtures – failed to stop  
water flow

**Site Photo 34. Water leak**

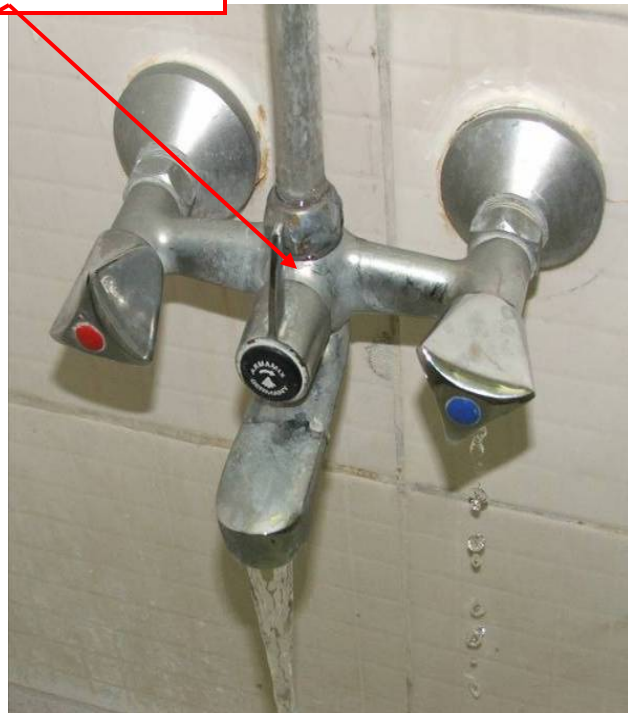
**Site Photo 35. Leaking shower faucet in cadet barracks**

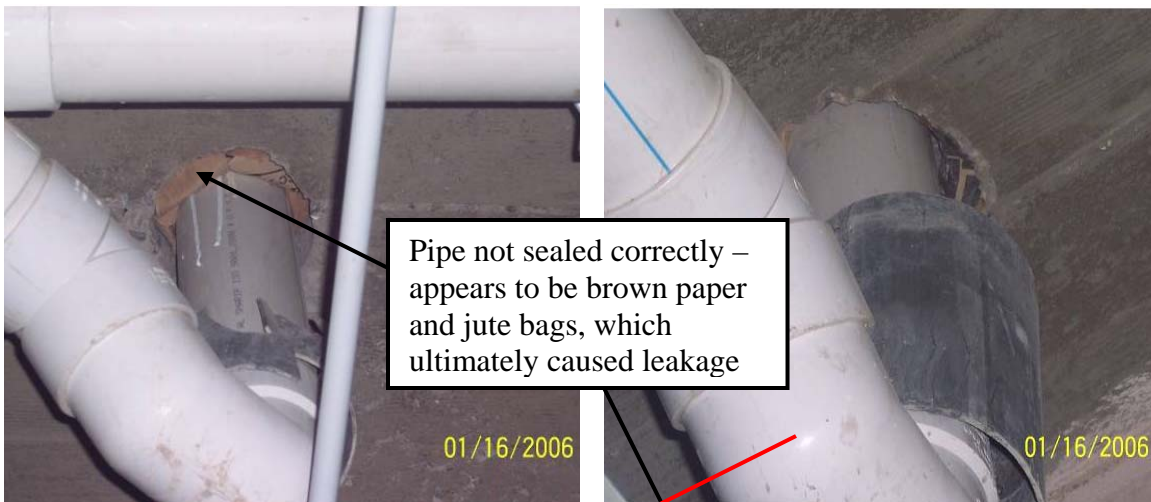
The cadet barracks’ NCR, dated 17 January 2006, stated “bad repair for sewage pipes through the slabs in Cadet Barracks Bathrooms” and included two photographs, which provided visual evidence of the improper connection and sealing of pipes (Site Photos 37 and 38). The NCR did not recommend any potential corrective actions nor did it mention if any corrective actions were taken to remedy the problem.

**Site Photos 37 & 38. Examples of poor quality work identified in Parsons' NCR (Photos courtesy of the USACE)**

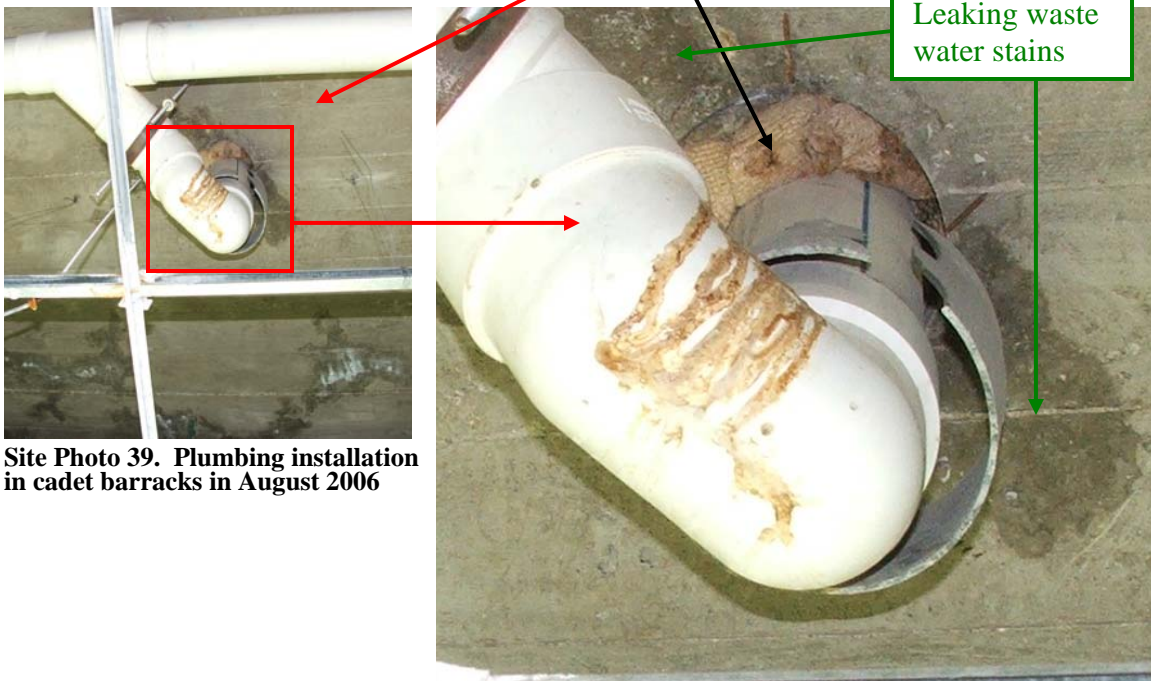
During our initial site visit, we identified either the same pipe (or one constructed in a similar manner), which confirmed the contractor did not take any corrective action to the NCR (Site Photos 39 and 40). The inability to act upon the NCRs resulted in the significant plumbing issues associated with the cadet barracks buildings. The poor soil pipe sealing work allowed waste water and solids to drain outside rather than inside the pipe, resulting in waste water leakage (Site Photos 41 and 42), which was a contributing factor to the significant water damage we witnessed on the ground floor.

Further, had the contractor’s QCR or project engineer inspected the plumbing issues identified in the NCR, he would have seen that the contractor was using non-industry standard plumbing fittings and installation methods. The contractor used pipes with holes that were hand cut and had secondary pipes inserted rather than the appropriate factory manufactured standard pipe fittings and components (Site Photo 3). Significant issues resulted from the poor installation of plumbing pipes and the use of non-industry standard fittings.

**Site Photo 39. Plumbing installation in cadet barracks in August 2006**

**Site Photo 40. Enlarged view of Site Photo 39**

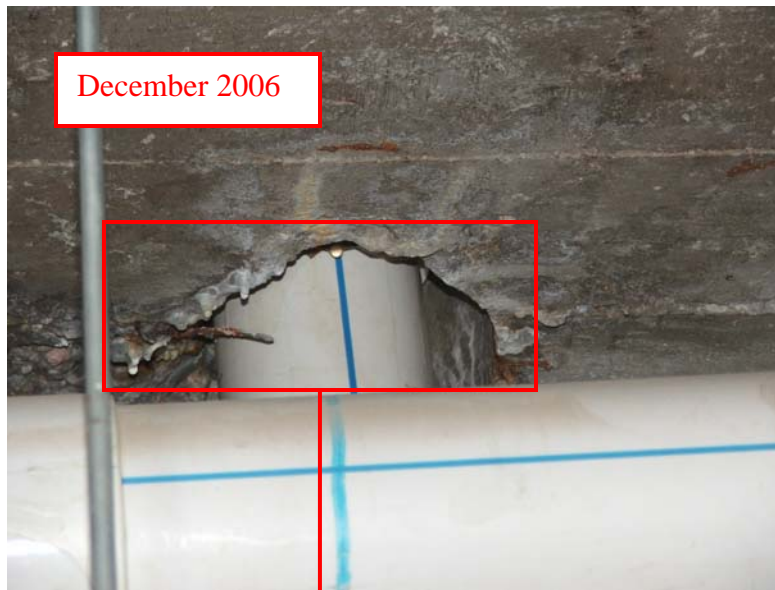
During our return site visits in November and December 2006, we again identified water leakages in the cadet barracks (Site Photos 41-44). While it appears this time the contractor did not use the non-industry standard pipes that contributed to the original leakage problem, the continuing issue of poor quality installation and inadequate seals between the soil pipe and fittings remained. The contractor QCR and/or project engineer failed to adequately perform oversight of the plumbing installation to ensure quality workmanship. As a result, the problem identified in the NCR in January 2006 continues to exist today.

**Site Photo 41. Water leaking from poorly installed drain in cadet barracks**

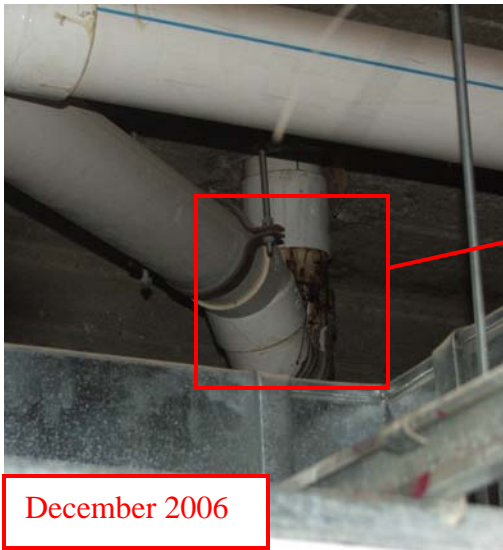
The final cause of the waste water leakage throughout the cadet barracks appears to be inadequate sealing of pipes, which resulted in waste water flowing outside of the pipes (Site Photos 43 and 44). The pipe sealing should have been caught by the contractor’s QCR or project engineer during installation and also through testing. The absence of proactive responses by the contractor allowed the plumbing issues to go unresolved. As a result, the cadet barracks’ bathrooms had to be torn up and redone; the Iraqi police cadets were subjected to waste water raining down upon them; and BPC did not have full use of the cadet barracks.

Site Photo 43. Leaking waste water from poorly sealed pipes

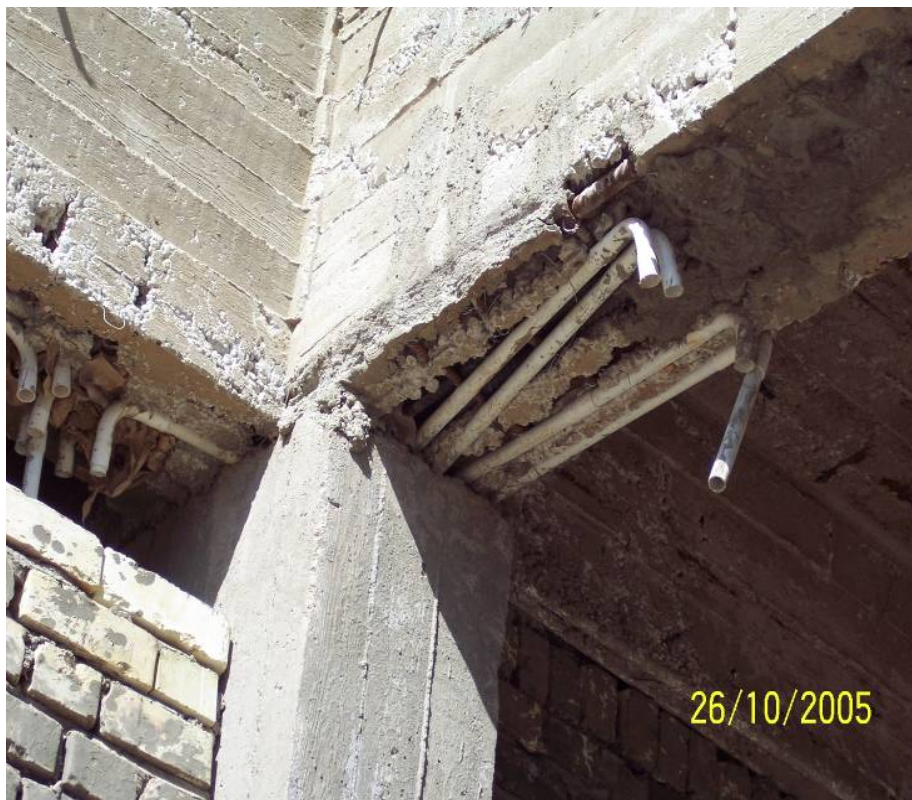
**Site Photo 47. Electrical conduit exposure (Photo courtesy of the USACE)**

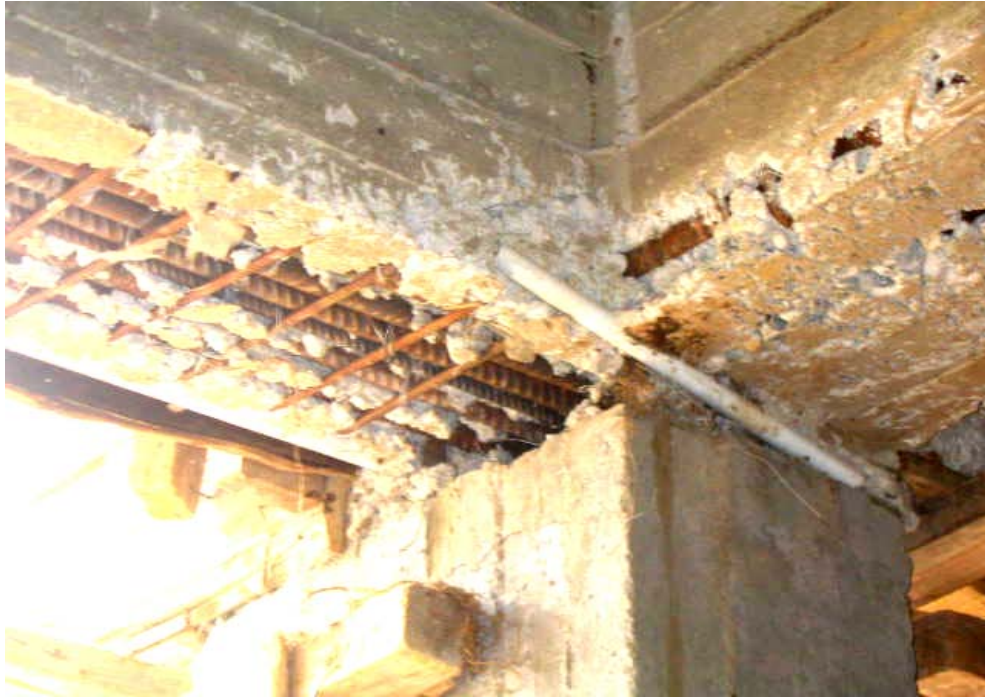
**Site Photo 50. Concrete segregation, reinforcement bar and electrical conduit exposure**  
(Photo courtesy of the USACE)

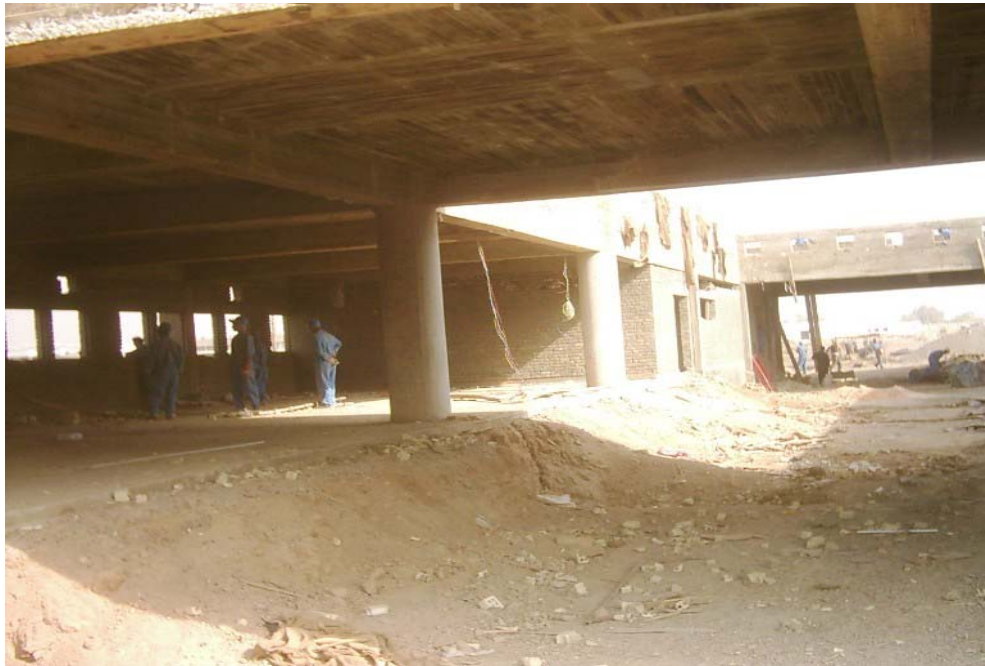
In the 26 November 2005 daily QA report, the QAR included a photograph from the interior of the laundry facility (Site Photos 51 and 52), which is almost identical to the photograph from the 30 October 2005 daily QA report, but did not mention any existing construction problems; rather, the report simply states “sanitary works are ongoing.” This daily QA report is over one month since Parsons discovered the massive concrete deficiencies throughout the facility. If Parsons did not bring the construction deficiencies to the USACE’s attention, work would have continued on the laundry facility, potentially increasing the dangers (and costs) associated with the building.

**Site Photo 51. QAR daily report photo of interior of central laundry facility from the 26 November 2005 daily QA report** (Photo courtesy of the USACE)

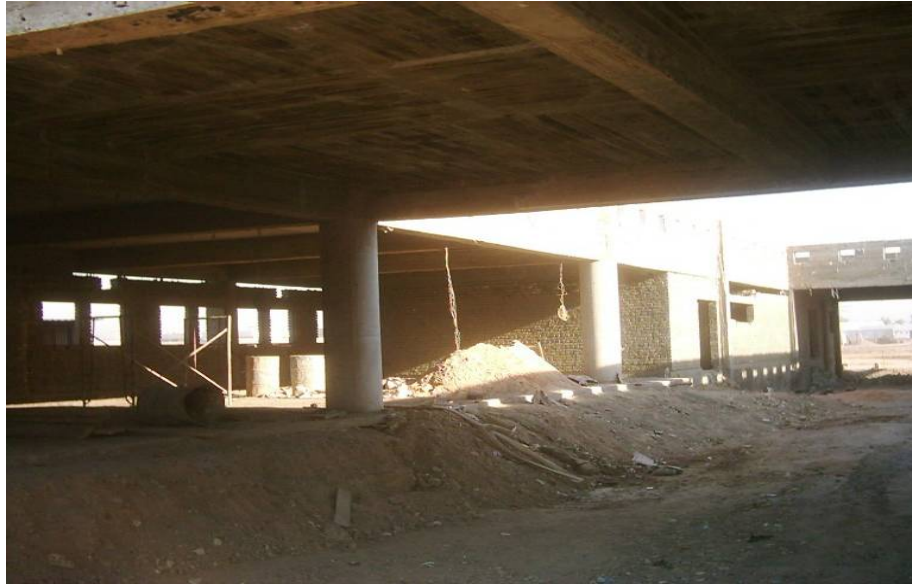
**Site Photo 52. QAR daily report photo of interior of central laundry facility  
(Photo courtesy of the USACE)**

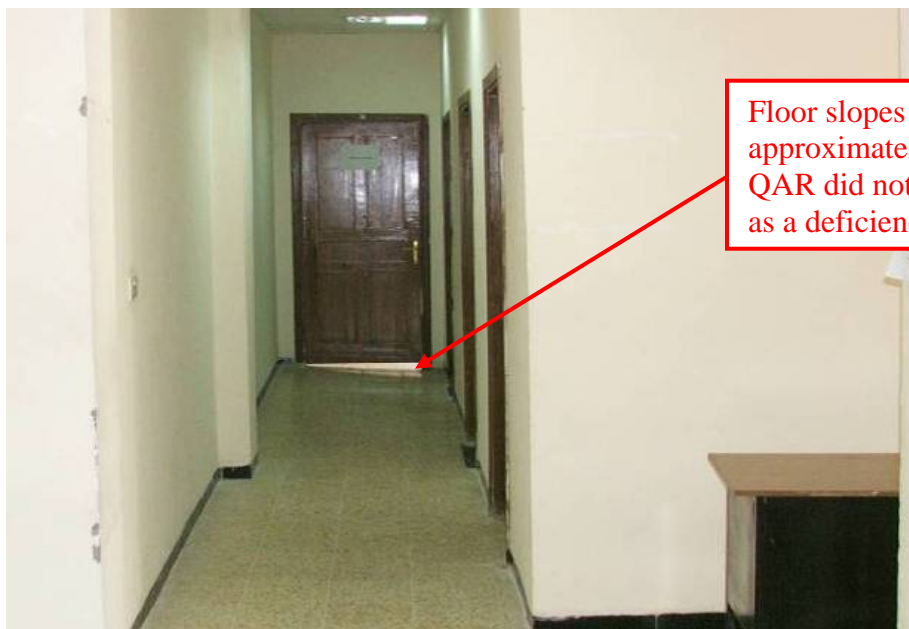
Further, the daily QA reports were not sufficiently complete and accurate. For example, the daily QA reports did not document the existence of the obvious construction deficiencies identified in this report, such as concrete segregation and honeycombing, reinforcement bar exposure, and poor plumbing installation in the cadet barracks. In addition, the “improper installation of roof flooring” in a majority of the buildings was noted by the GRD’s independent assessment report; however, this issue was never discovered nor noted in the daily QA reports. In classroom building E, we determined the ground floor sloped approximately 4” to the right (Site Photo 53); yet this was not recognized as a deficiency in the daily QA reports.

Floor slopes to the right approximately 4” – the QAR did not identify this as a deficiency

**Site Photo 53. View of poor construction for classroom E**

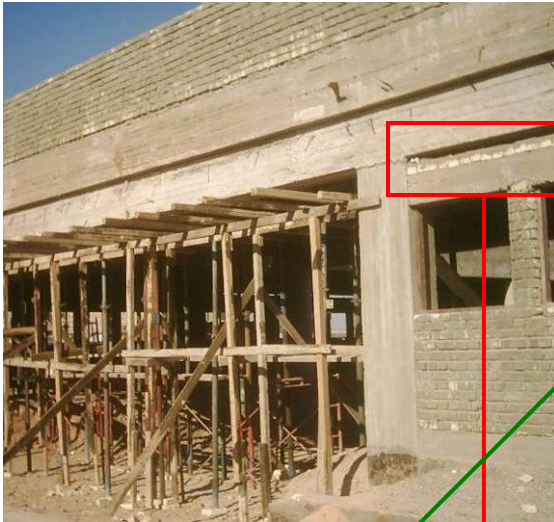
In some cases, the daily QA report provided photographs of poor construction work; yet the narrative did not document the deficiency. For instance, one daily QA report included a photograph of poor concrete quality beneath a lintel (Site Photos 56-58); however, the narrative daily report did not mention this problem nor does it mention if the QAR brought this problem to the contractor's attention. Instead of documenting the deficiencies and proposing potential corrective actions, the daily QA report simply stated "No activity" on that particular day for the laundry facility. By review of the daily QA reports, we were unable to determine if the contractor corrected this problem. It appears that the QAR did not receive proper training to identify poor workmanship issues.

**Site Photo 56. QAR provided photograph of poor construction (Photo courtesy of the USACE)**

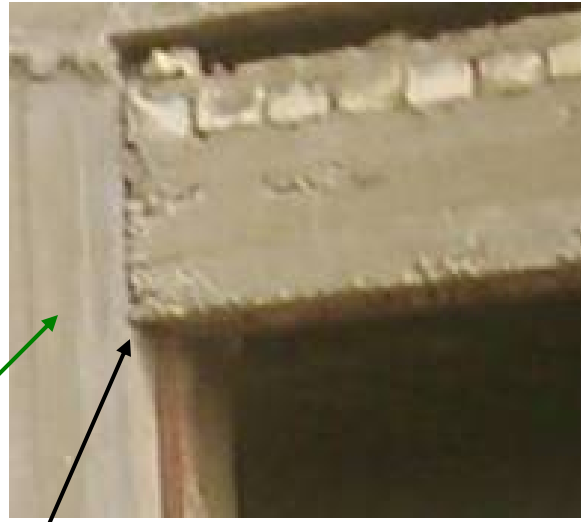
**Site Photo 57. Enlarged portion of Site Photo 58**

The USACE GRC Project Engineer did not effectively review the daily reports and monitor the performance of the LN QA engineers. The LN QAR periodically provided the USACE GRC Project Engineer photographic evidence of poor concrete workmanship (Site Photo 57), yet there is no indication that the Project Engineer tried to correct this issue. Further, the USACE Project Engineer and Resident Engineer did not effectively monitor performance of the LN QAR. The Project Engineer and Resident Engineer at a minimum should have periodically reviewed the LN QC and LN QA daily reports to determine the progress of the projects and the quality of the contractor's work. It does not appear that either the Project Engineer or the Resident Engineer thoroughly reviewed the daily reports. For example, the daily QC reports documented construction deficiencies; while the daily QA reports did not. On 19 September 2005, the daily QC report for the instructors' barracks stated:

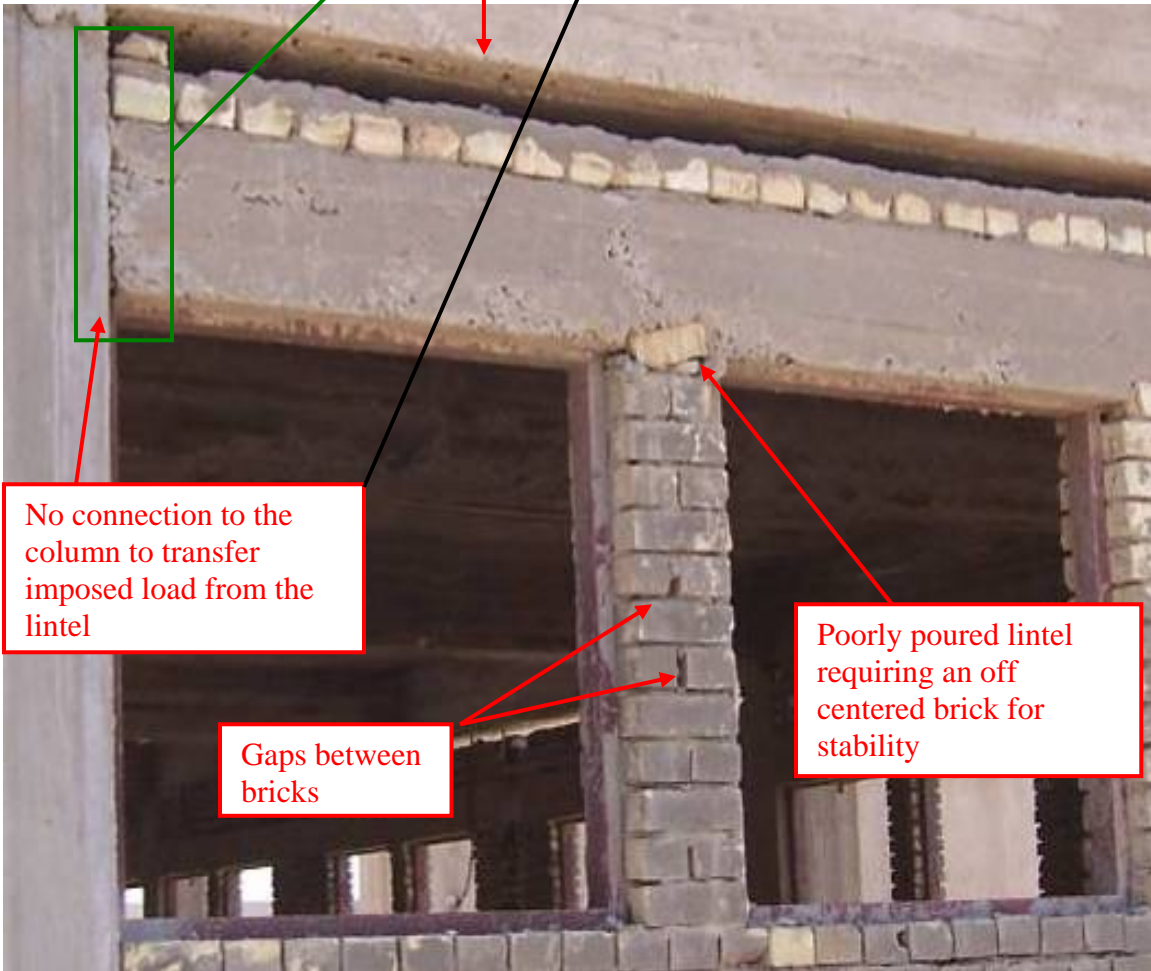
**Site Photo 58. Enlarged section of Site Photo 56, detailing poor construction practices**

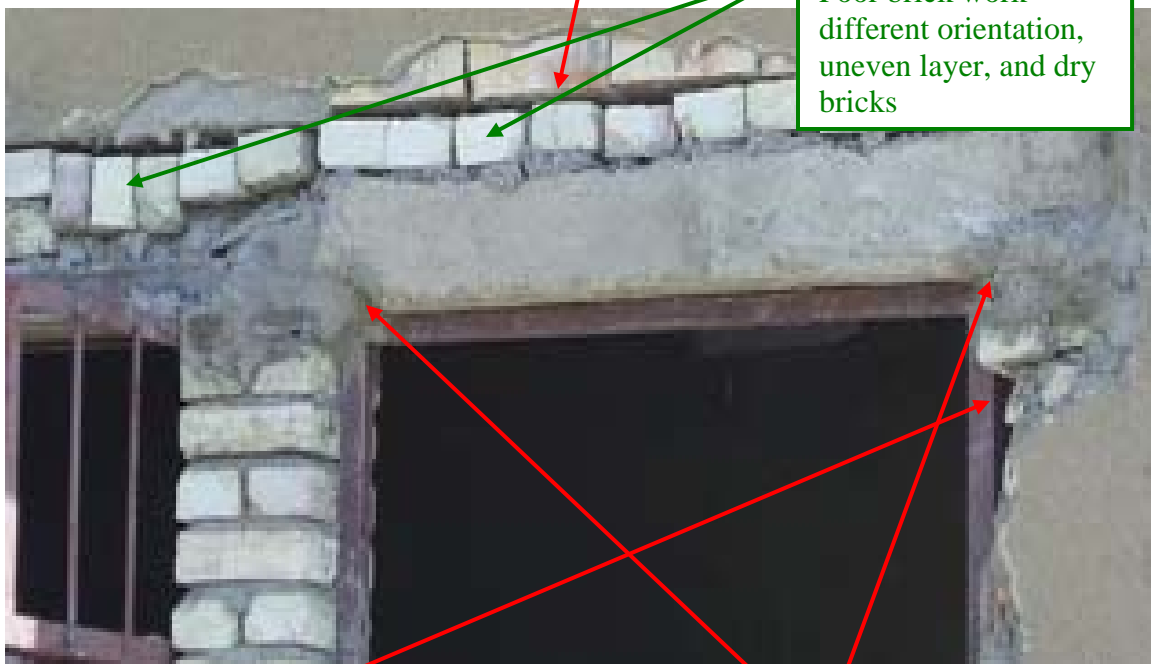
Poor brick work – different orientation, uneven layer, and dry bricks

**Site Photo 60. Close-up section of Site Photo 59, documenting poor lintel construction practices**
